# REPORT OF THE SAFOD ENGINEERING SUBCOMMITTEE OF THE ADVISORY COMMITTEE FOR GEOSCIENCES, MARCH 30, 2011

#### **D. Reasons the 2008 Observatory Ceased to Operate**

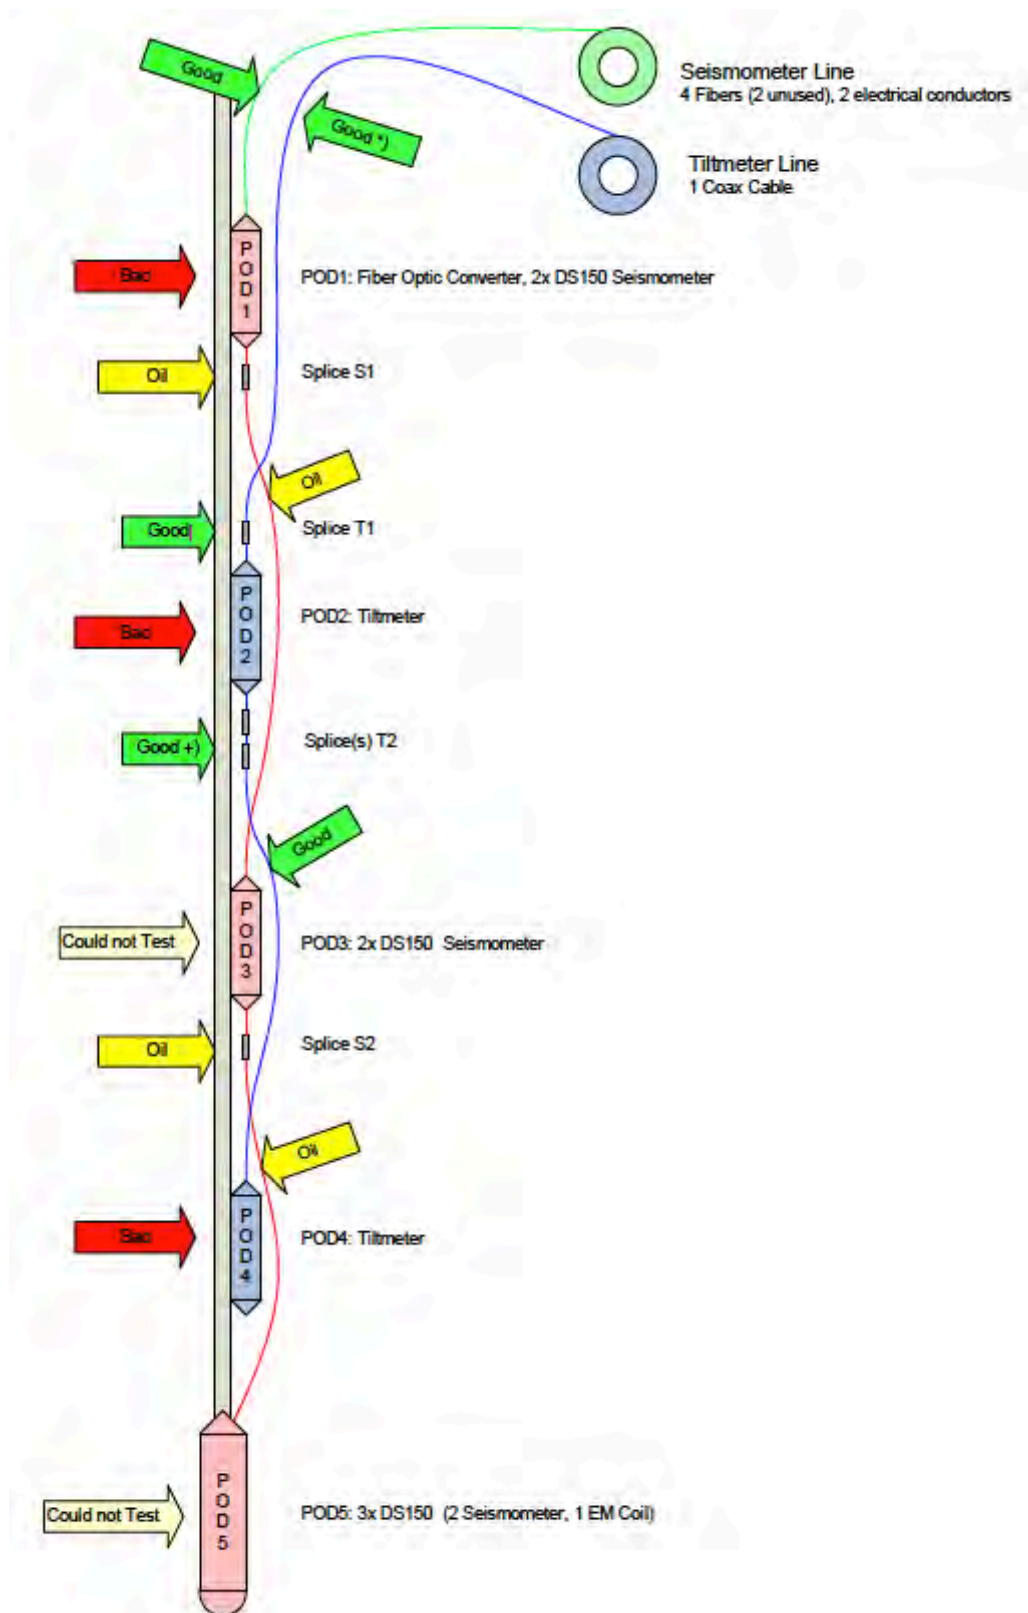
Figure 3 SAFOD DIP Showing the Two Separate Control Lines

- A broken wire was found in Splice S2 (see Figure 3). It is not clear if the break occurred before or during disassembly.

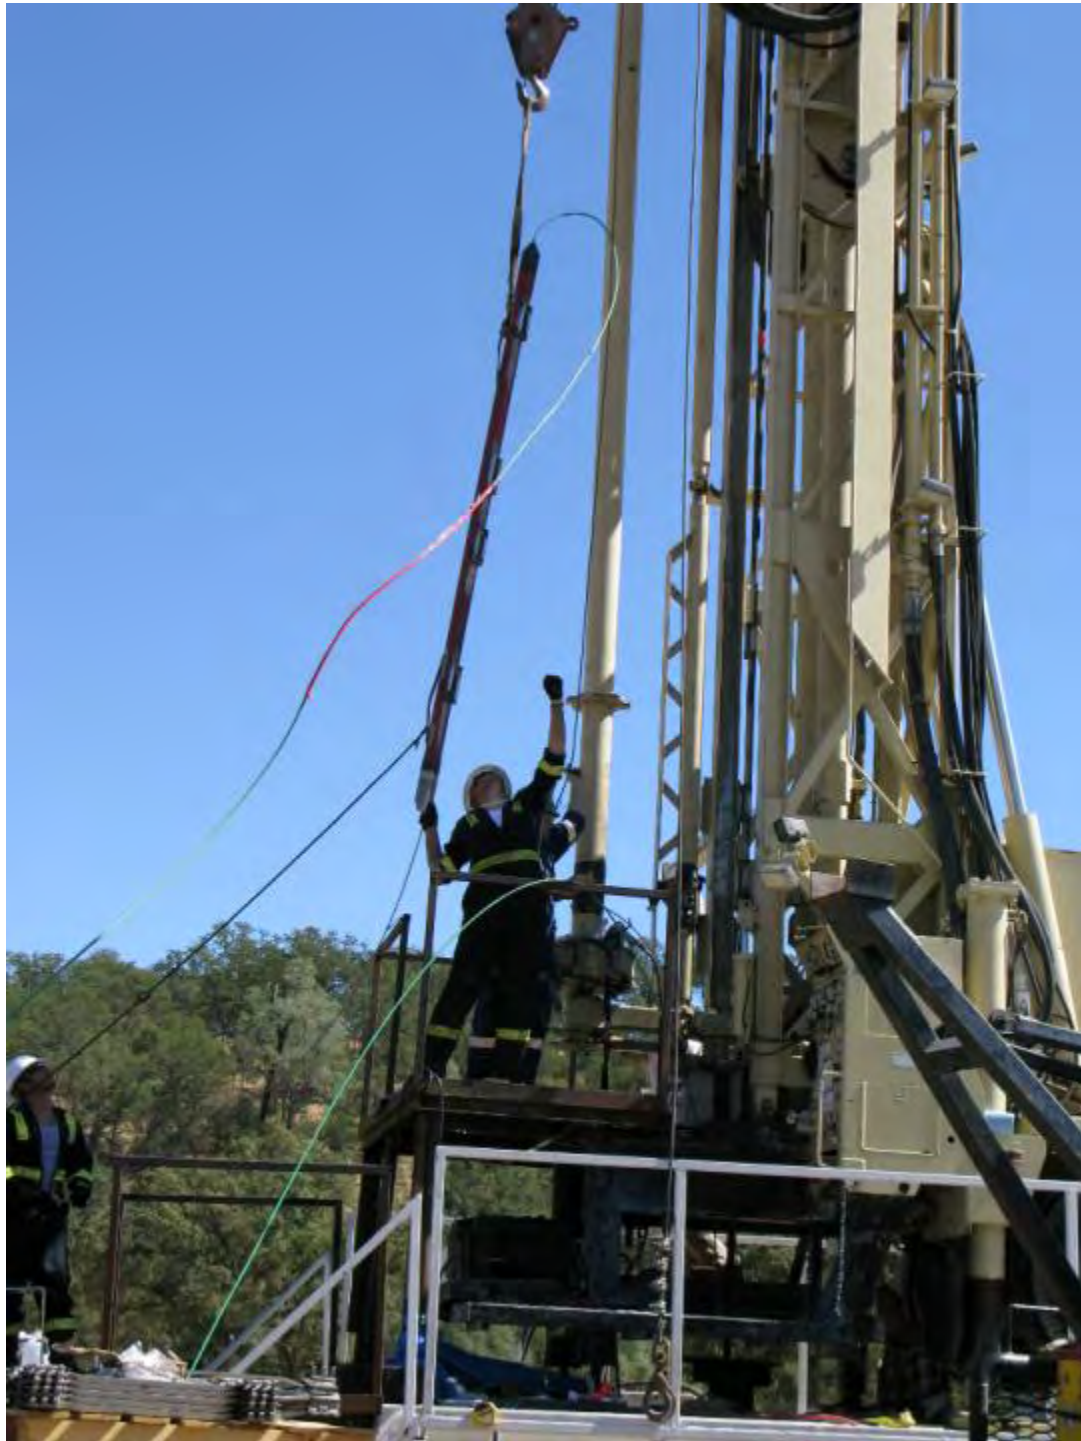
**Figure 4     Installing a Pod - Control Lines are Clearly Visible**

Lastly, the committee noted that the metal-metal contact surface in a Swaged coupling is small and may be easily compromised during insertion into the wellbore, which is a rather rough handling process (see for example Figure 4). In addition to rough handling, each swaged connection can be compromised by dirt or debris between the cone and seat of each connection. It was not clear to the committee to what extent the attention to detail, as noted above, was an essential theme of the fabrication and installation process. The committee did note that the clamping of the 1/4 inch tubing to the EUE tubing was a good idea, and had potentially reduced the chances of additional failures.

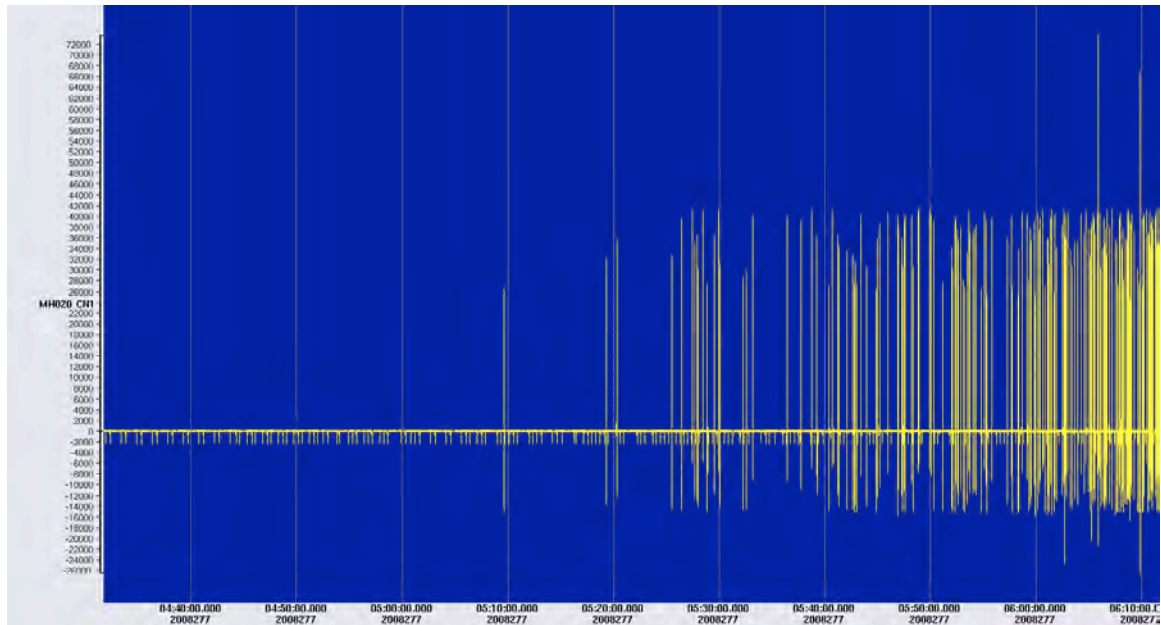
1. The tiltmeter in Pod 4 lost contact with the surface before the DIP hit bottom. The failure was probably due to an open circuit that occurred during installation.
2. The tiltmeter in Pod 2 began to have problems shortly after deployment and stopped working two weeks later. It was found to be partially filled with oil during disassembly, suggesting a leak at one of the O-ring seals.
3. The seismic array arrived on the bottom fully functional, but problems began after several days. A perplexing pattern of noise developed with a 24-hour cycle (possibly due to ground loops).

**Figure 6 Spikes Developing in Seismic Data**

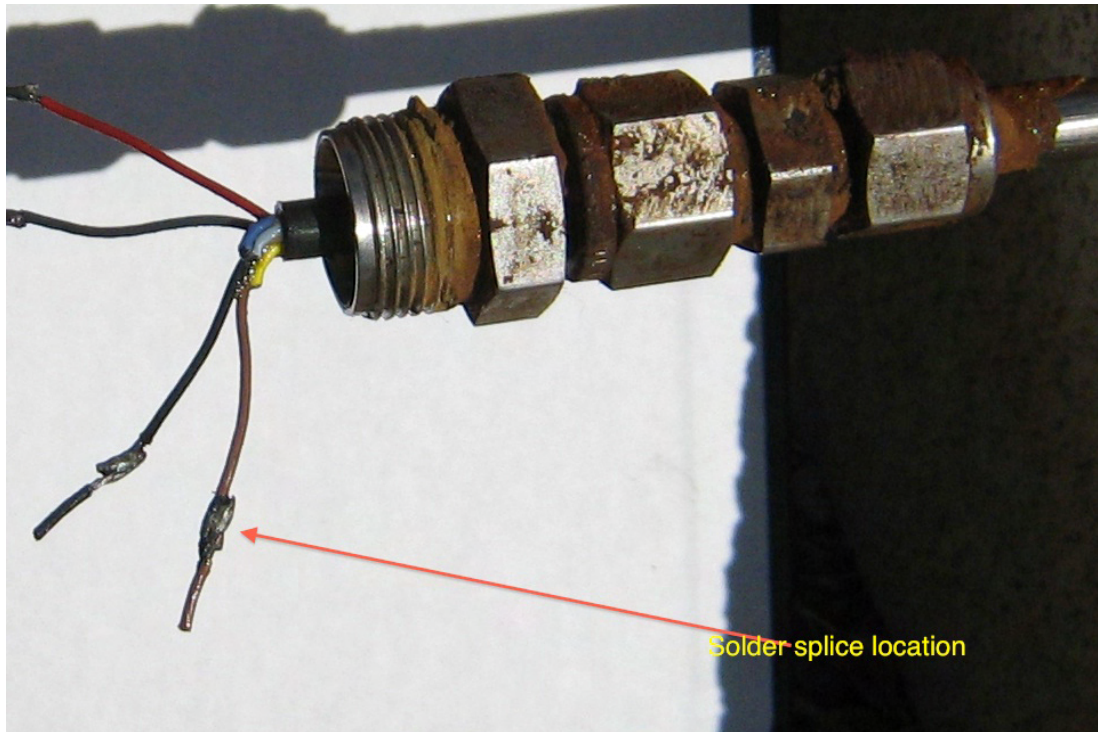
- The Mobil 1 had migrated between Pods through the ¼ inch tubing, indicating that the cable heads were probably compromised in some cases.
- Electrical splices between Pods were poorly done. The exposed ends of the wires were placed parallel to one another and soldered with no mechanical connection (Figure 8). Individual splices within their protective steel tubes were not staggered. A broken brown wire was found to have occurred near splice S2 between Pods 3 and 5. Insulation materials around the soldered connections had badly deteriorated in many cases. This may have allowed conductive fluid that migrated along the ¼ inch tubing and into the splices to create short-circuits between individual splices.

Figure 8 Poorly Soldered Splices

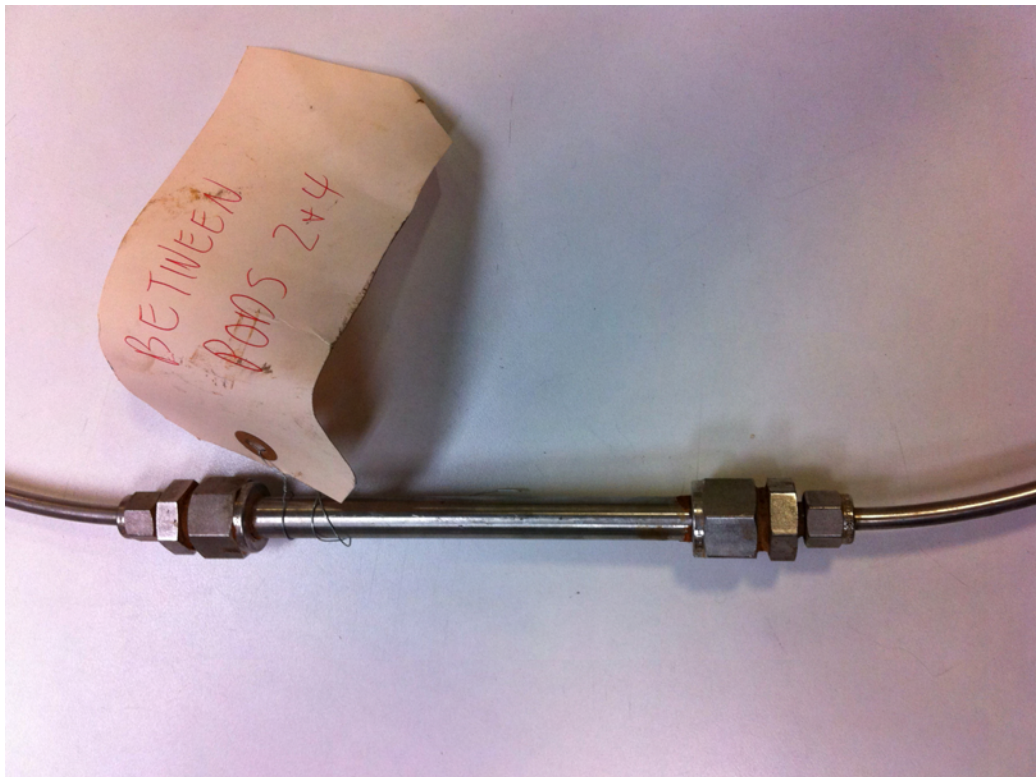
Figure 9 Splice Housing Between Pods 2 and 4

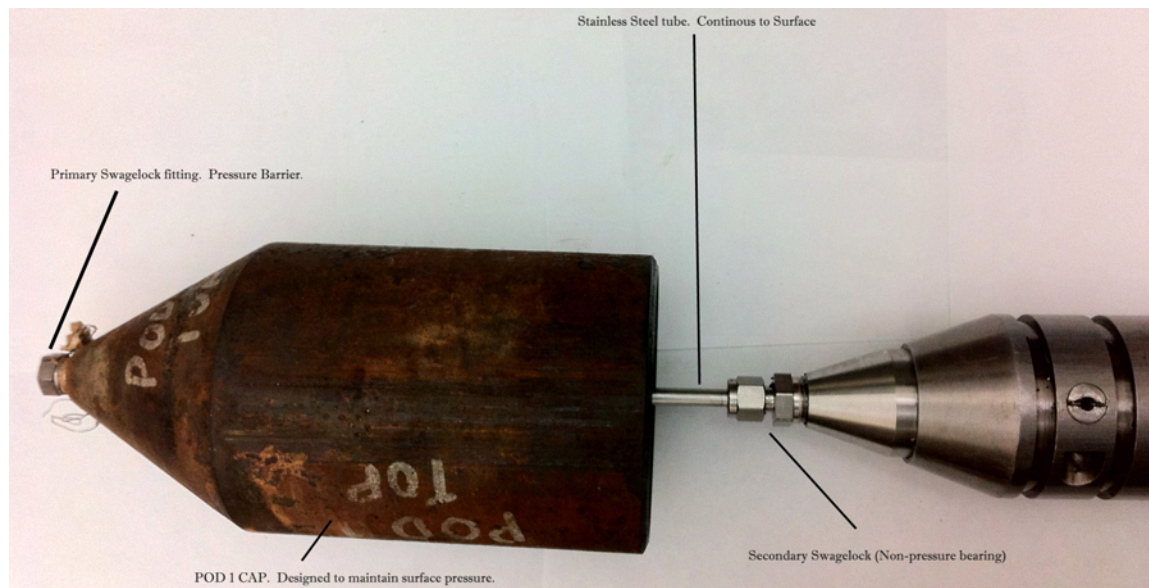
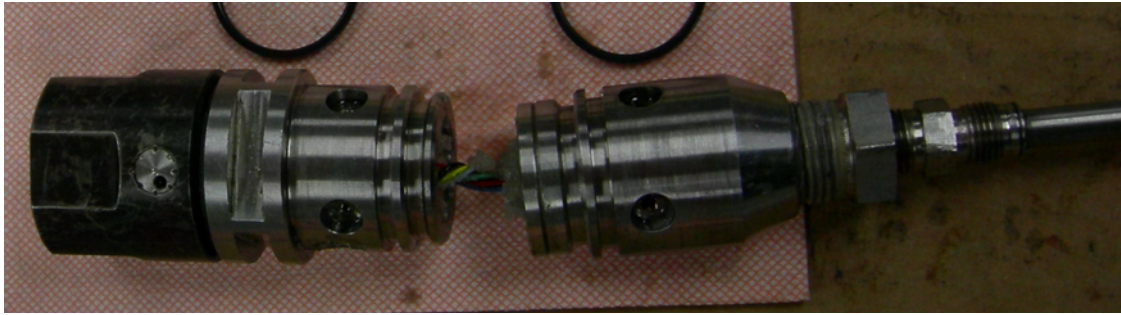
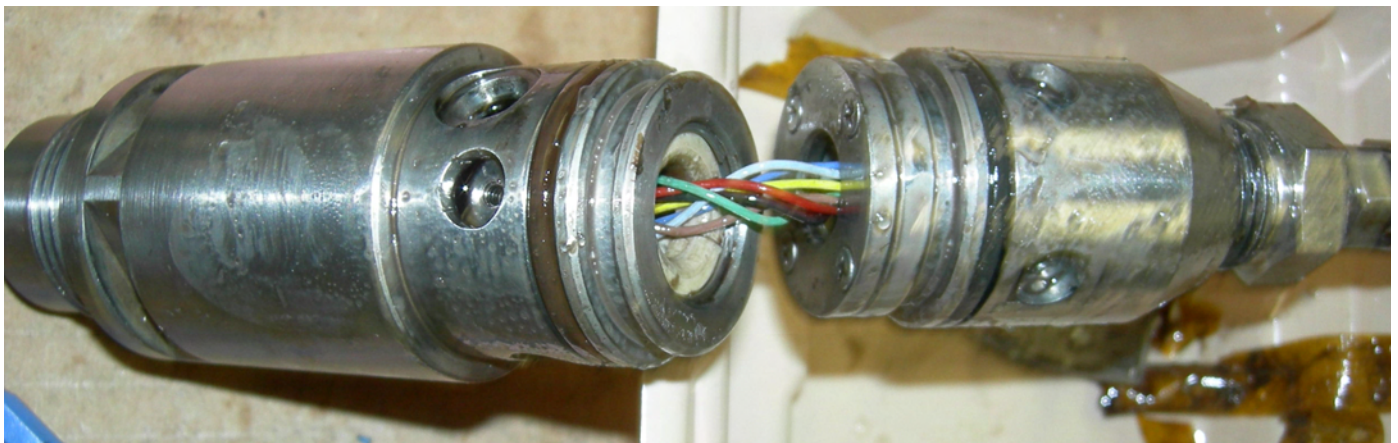
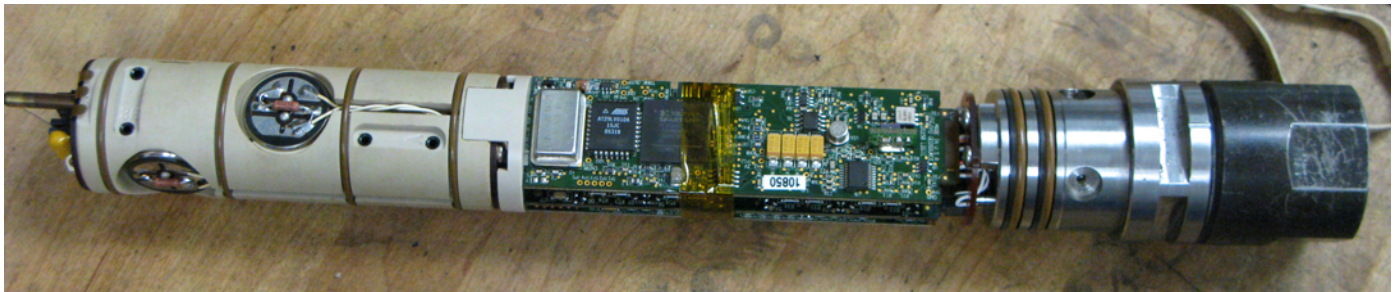
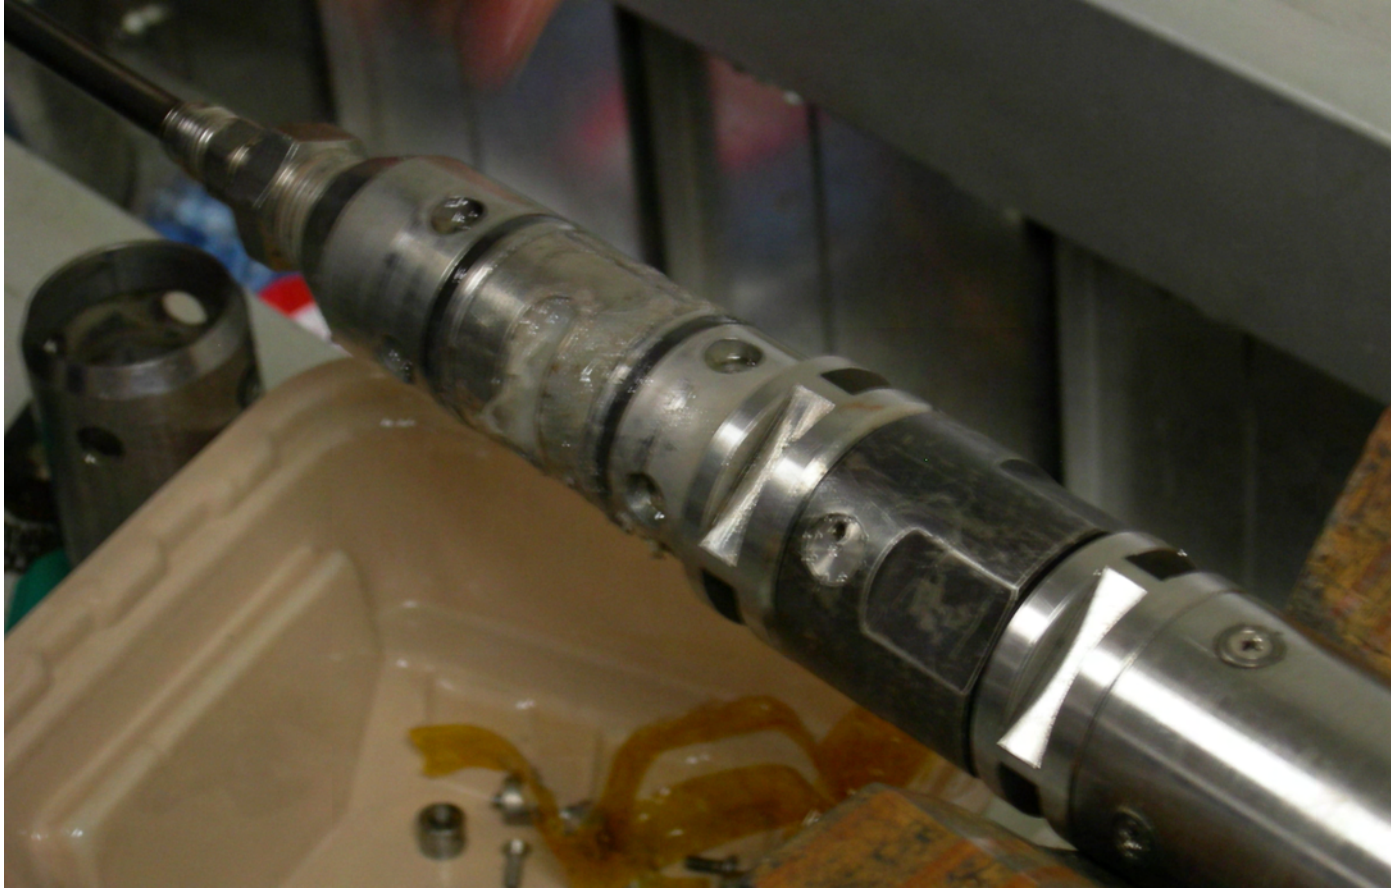
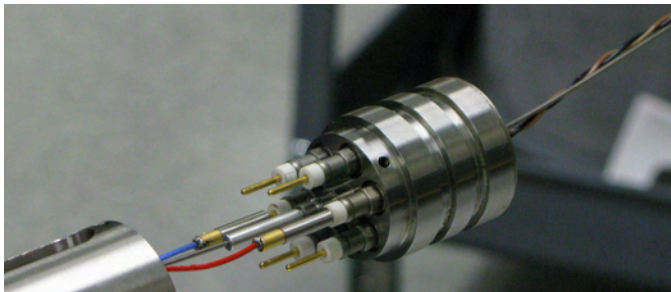
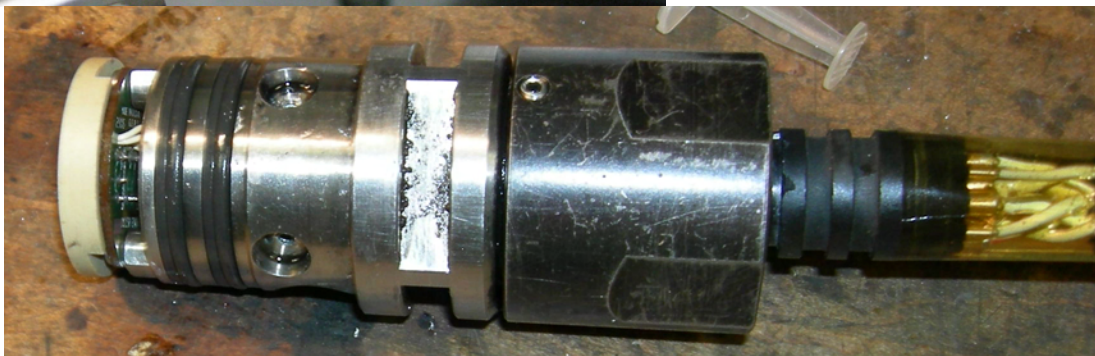
- ❖ The committee recommends that further study be performed on the actual O-rings and feeds-thru (Figure 10) used in the DIP to determine if they maintained integrity (blocking fluid, gas, and volatiles) during the two years the DIP was in the SAFOD borehole. It would also be useful to perform various stress tests on Swagelok fittings to determine if they can hold up under the rigors of installation, as well as for long periods under corrosive fluid and gas conditions.
