# REPORT OF THE SAFOD ENGINEERING SUBCOMMITTEE OF THE ADVISORY COMMITTEE FOR GEOSCIENCES, MARCH 30, 2011

#### **D. Reasons the 2008 Observatory Ceased to Operate**

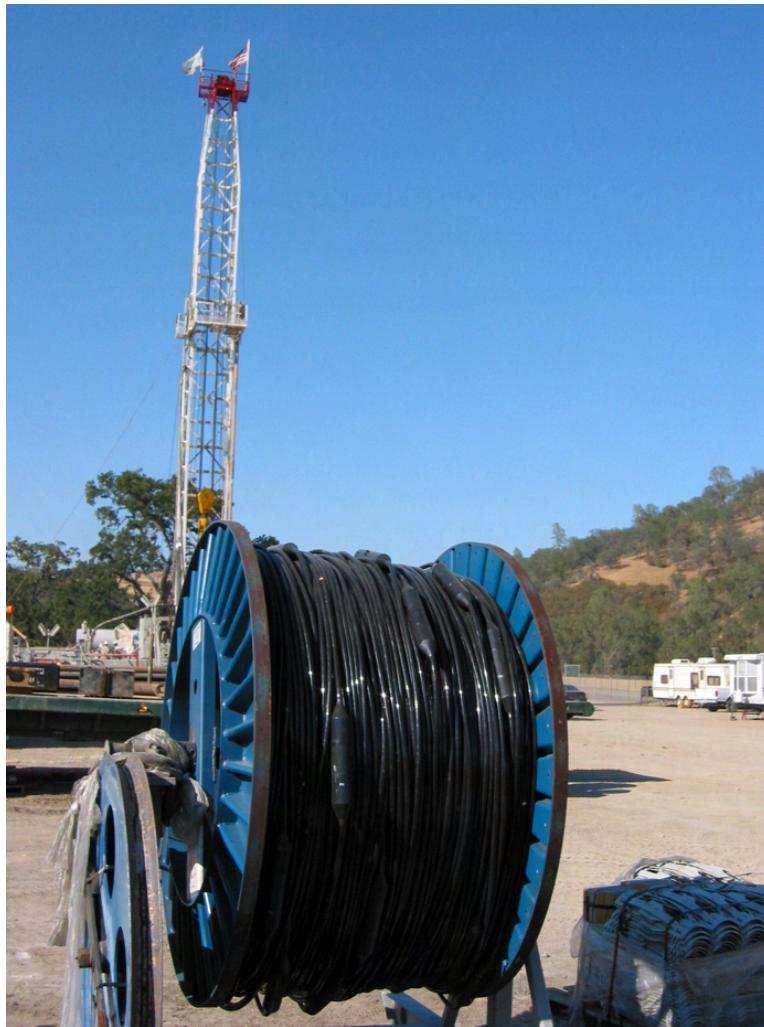
**Figure 5    Downhole 240 Channel 80 Level Geophone Array**

All of the MH001 to MH017 deployments were carried out on a standard wireline that was donated (used) by Oyo/Geospace, with the exception of deployments MH004 to MH006, which consisted of a passive 240 channel, 80 level, 3-component geophone array on a specialized cable (Figure 5) containing individual twisted conductor pairs. The array provided good data for low-amplitude signals. However, the clamping force was not sufficient to prevent crosstalk between the channels for higher-amplitude signals and the recording of target events.
